Height Adjustment:

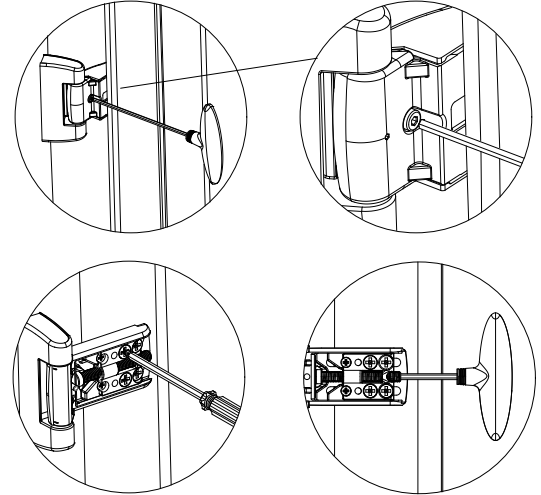
Horizontal Adjustment:

With the door in the open position locate the cover cap screw and remove it using a 3mm Allen Key. Be careful whilst removing as this will release the main cover cap and could potentially drop to the floor.

Using the correct screwdriver slightly release the fixing screws taking pressure off the adjustment bolt. Adjustment can be made using a 4mm Allen Key. Turn the adjustment bolt clockwise to move the door away from the hinge side and towards the lock side. Anti-clockwise to move the door closer to the hinges.

Remember to re-tighten the fixing screws once adjustment has been made and replace the cover cap.

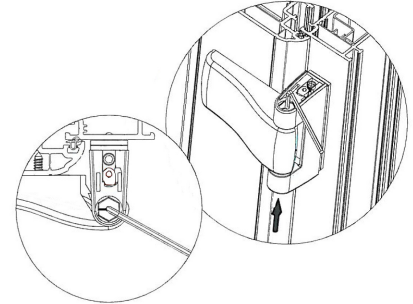
Compression Adjustment:

With the door in the closed position, remove the top cover cap by applying pressure on the rear surface as shown opposite. The front of the cap should lift, you may need to prise it gently to remove it.

Open the door so that you can see the reverse of the hinge. Using a 2mm allen key loosen off the pin security grub screw located at the rear of the hinge, this will allow the compression pin to move freely.

Tap the pin from the underneath, see arrow opposite until the hexagon head of the pin is free to rotate (approx 10mm up). Using a 4mm allen key rotate the pin either clockwise or anti-clockwise to obtain the required compression setting.

Note that the neutral setting should see the small line on the top of the hexagon head facing the 9 o'clock position.

To finish ensure that the 2mm security grub screw on the reverse of the hinge has been re-tightened and then replace the end cover cap.
